**2012 Annual Inspection Report**

**BRADY CANAL HYDROLOGIC  
RESTORATION PROJECT (TE-28)**

State Project Number TE-28  
Priority Project List 3

July 15, 2012  
Terrebonne Parish

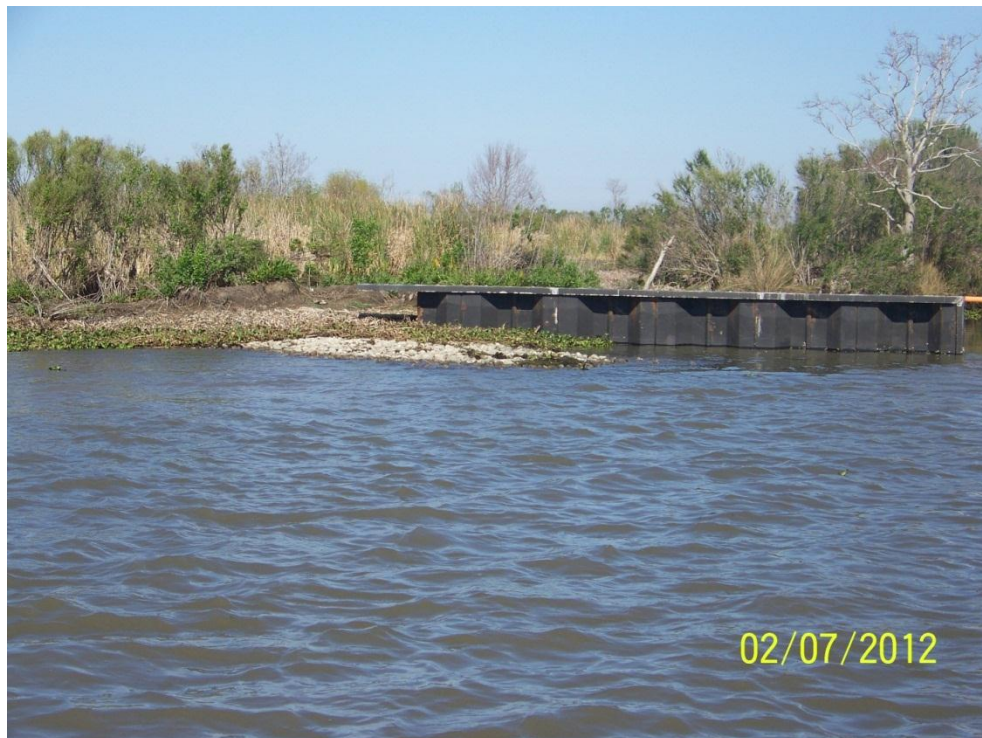
Photo #28: Embankment tie-in on southwest side of Structure 21 has been eroded but does not allow water to flow around the structure, view looking north from Jug Lake.

The variable crest weir structures along the rim of Jug Lake will have their earthen embankment tie-ins refurbished during the 2012 Maintenance Project. This will consist of utilizing fill material from the lake bed to rebuild their tie-ins to the original design specifications. In addition to the earthen embankments, it is recommended that the tie-ins be armored with rock riprap 50 linear feet in both directions to prevent further erosion and breaches. Due to the high cost of rock riprap placement, the armoring of Structure 23, which has a history of breaches and is in the worst condition of the three weirs, has been included in the base bid of the 2012 Maintenance Project. The armoring of Structures 21 and 24 have been included in the project as Alternate Bids #1 and #2 respectively, as these have experienced less erosion and will be armored with rock riprap if the budget allows.

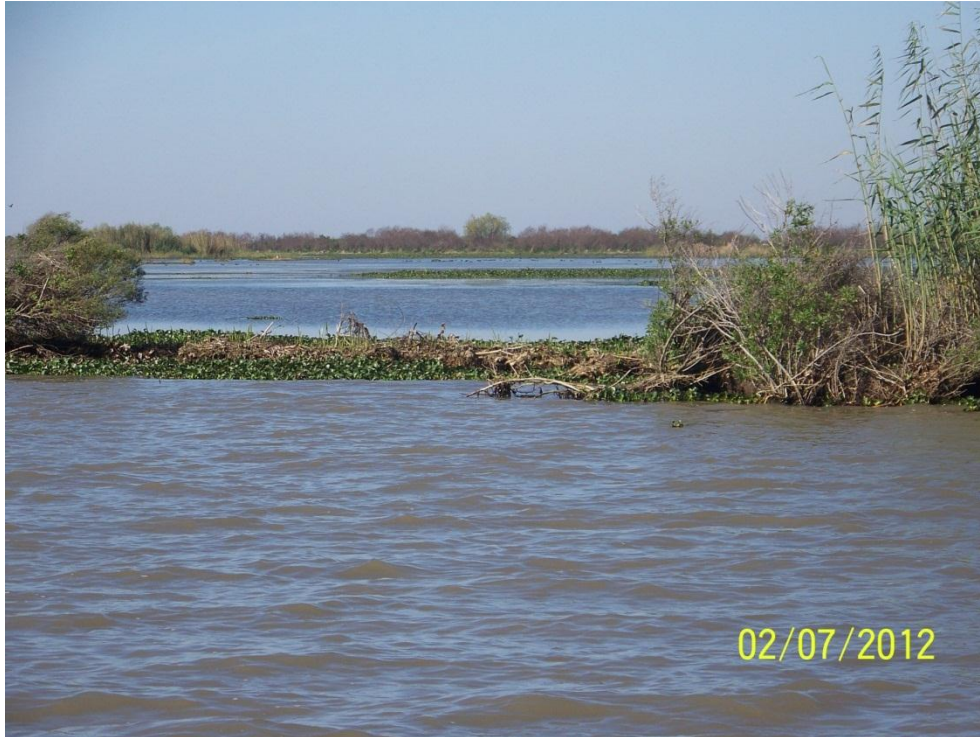
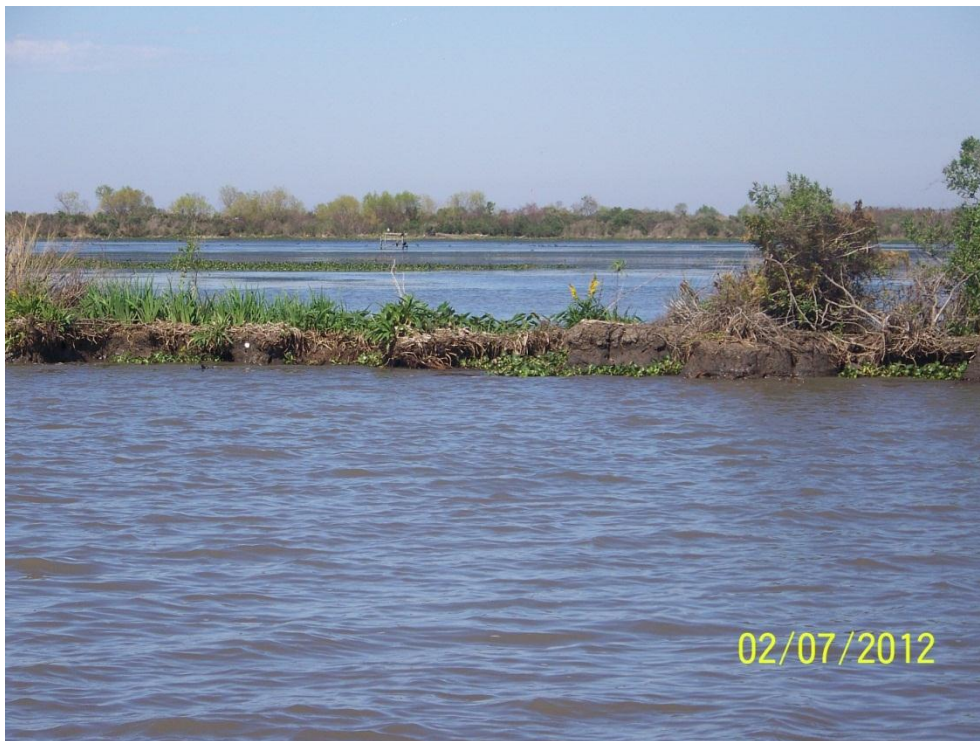
Photo #29: View of low section in lake rim along northwest Jug Lake, looking northwest.

Photo #30: View of low section in lake rim along northwest Jug Lake, looking northwest.

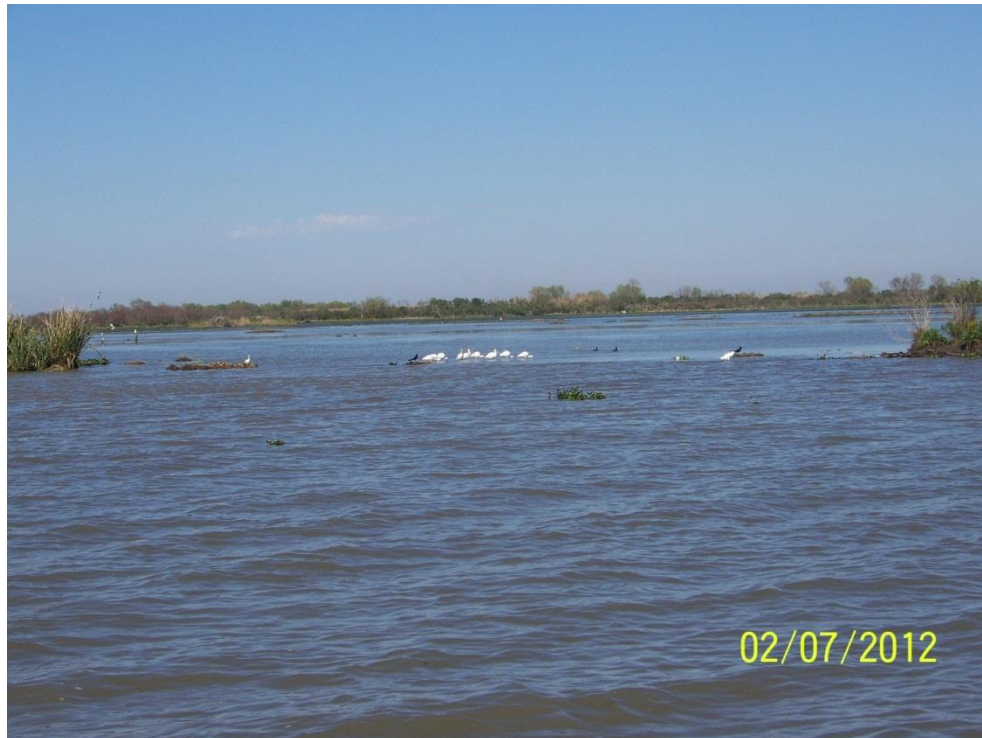
Photo #31: View of breach in lake rim along northwest Jug Lake, looking northwest. The size of the breach has increased since 2011 annual inspection.

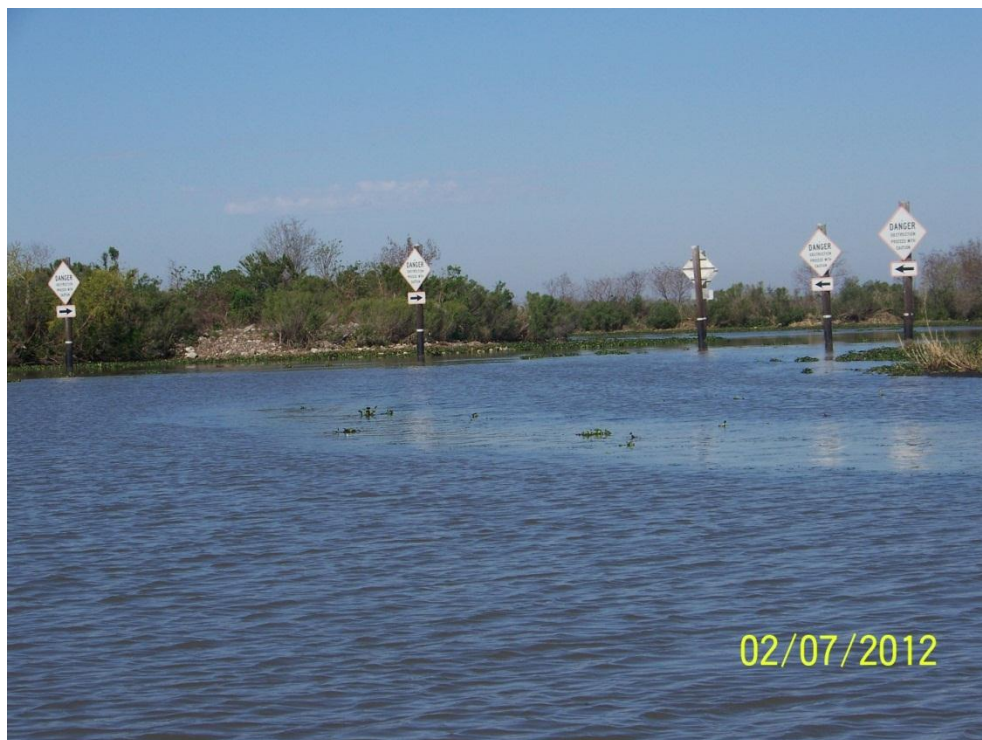
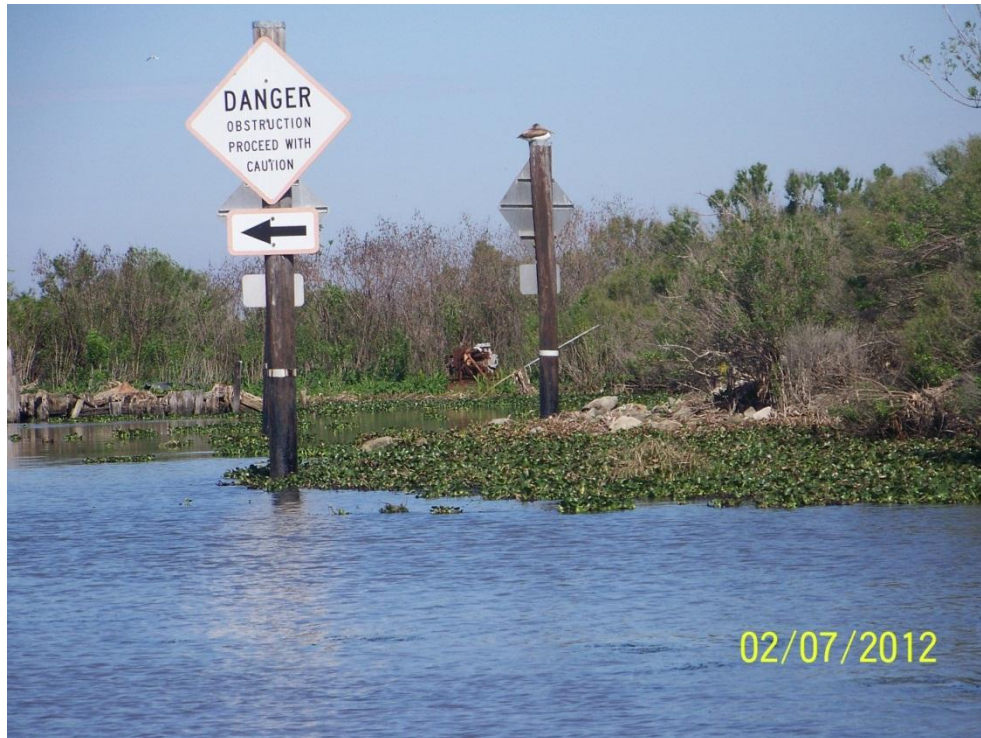
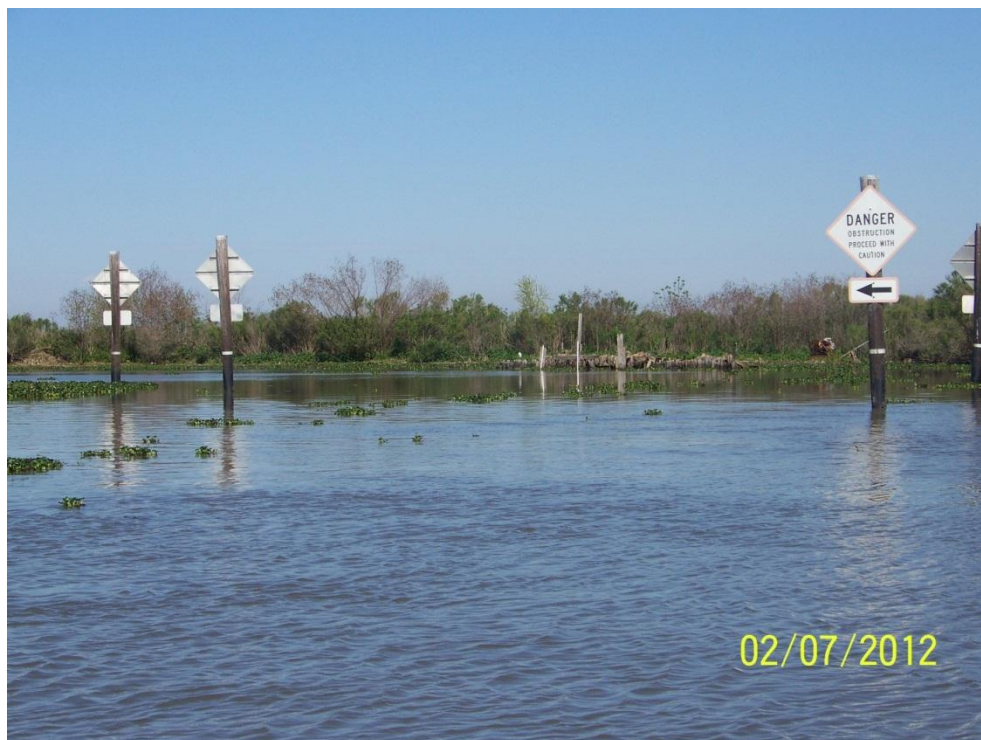
This structure is in fair condition. There has been some settlement of the rock rip rap on both the exposed sides and submerged crest of the structure. A handheld depth sounder was used to record the water depth in the boat bay. A reading of 6.7' of water above the rock crest combined with the earlier water level reading of +1.0' NAVD implies the current crest of the structure is -5.7' NAVD. When compared to its constructed height of -4.75' NAVD the crest has settled approximately 1.0'. All other warning signs and timber supports are in good condition. (See Appendix B, Photos 32 through 34)

Photo #32: Overall view of Structure 20 looking northwest from Jug Lake. All warning signs and support timbers are in good condition.

Photo #33: View of the eastern embankment tie-in of Structure 20 is obscured by vegetation, looking northeast from Jug Lake.

Photo #34: Additional view of Structure 20 warning signs and support timbers looking south from navigational canal.

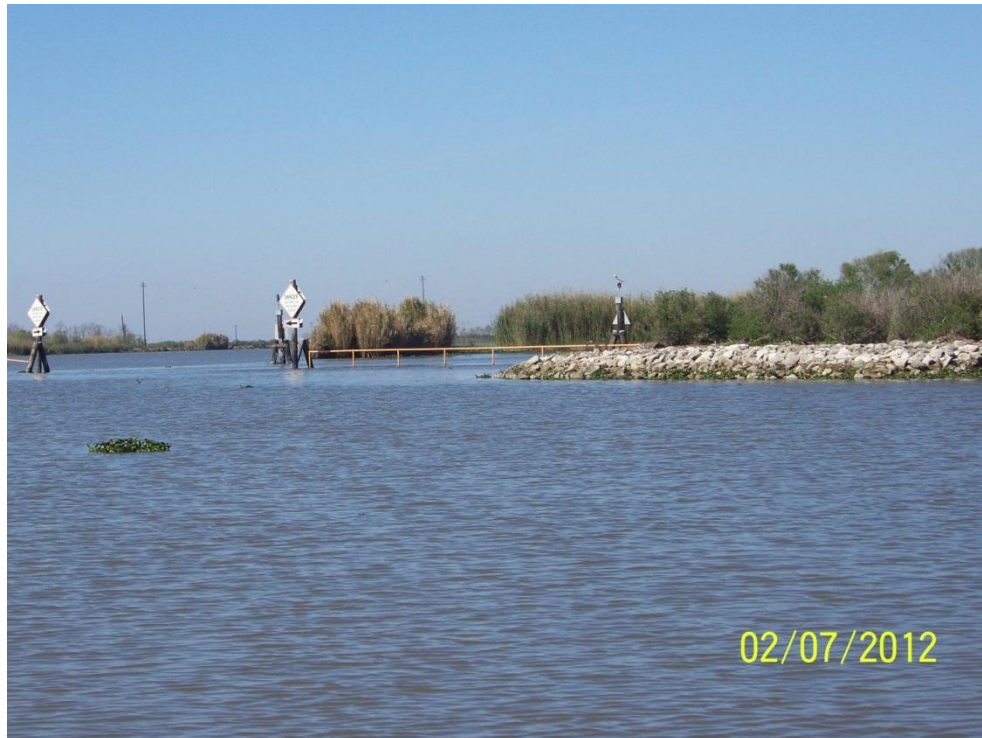
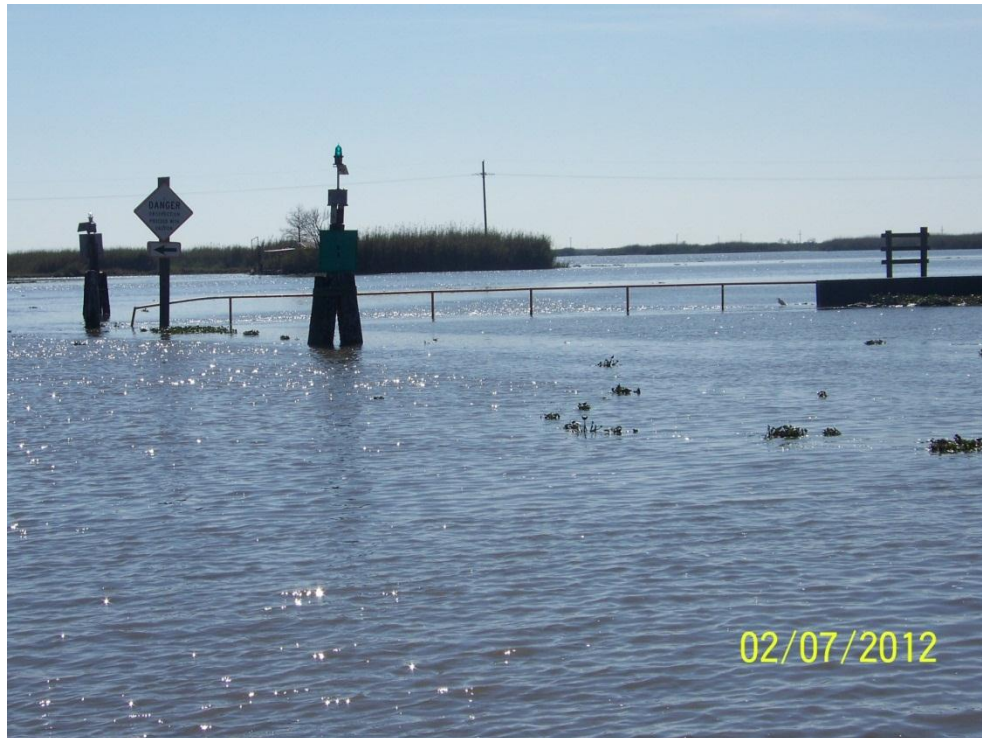
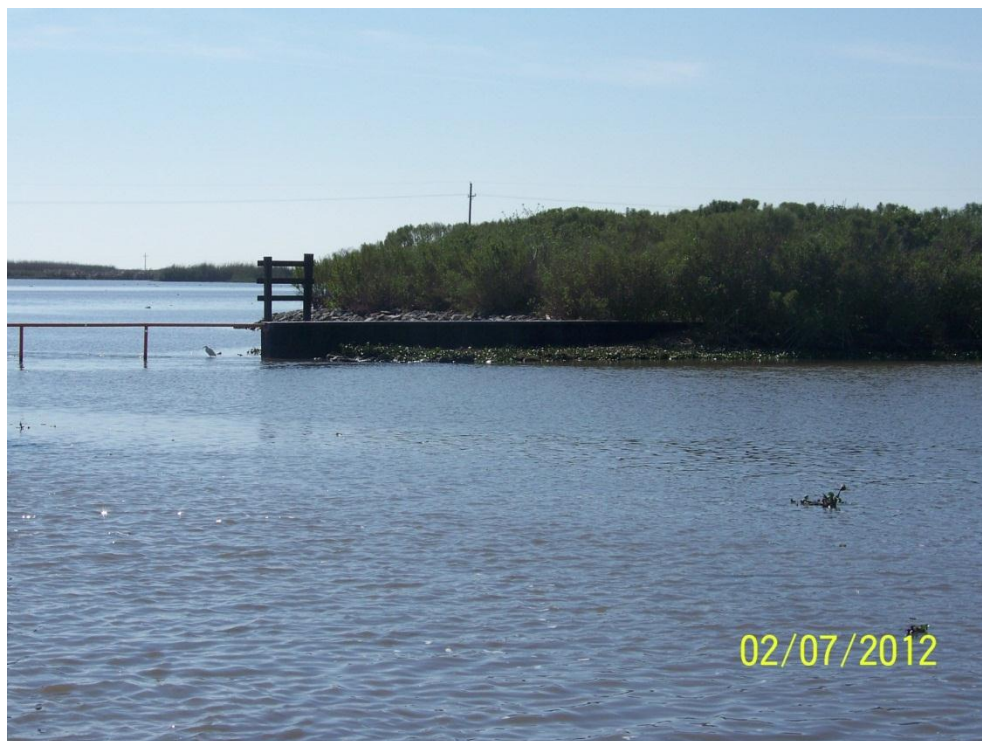
Structure 6 appears to be in good overall condition. The steel bulkheads and embankment tie-ins show no signs of erosion or wash-outs. The navigational lights appear to be working and the navigational signs are visible despite some minor corrosion from exposure. As mentioned in previous inspection reports, the timber pile dolphins on the south side of the structure are cracked and displaced from their original placement. This damage is believed to be due to oilfield service barges using the timber pile dolphins to navigate the sharp turn from Bayou Decade. These timber repairs are included in the 2012 Maintenance Project which is going to bid on July 24, 2012. A water level reading of +1.0' NAVD88 was taken at approximately 11:15am from a project staff gauge near Structure 6. (See Appendix B, Photos 35 through 38)

Photo #35: View of the eastern end of Structure 6 and rock armored embankment, looking north from Bayou Decade.

Photo #37: Overall view of the western end of Structure 6, looking south from navigational canal.

Photo #38: View of the western embankment tie-in of Structure 6, looking south from navigational canal. There is no visible erosion or breaching around the tie-in

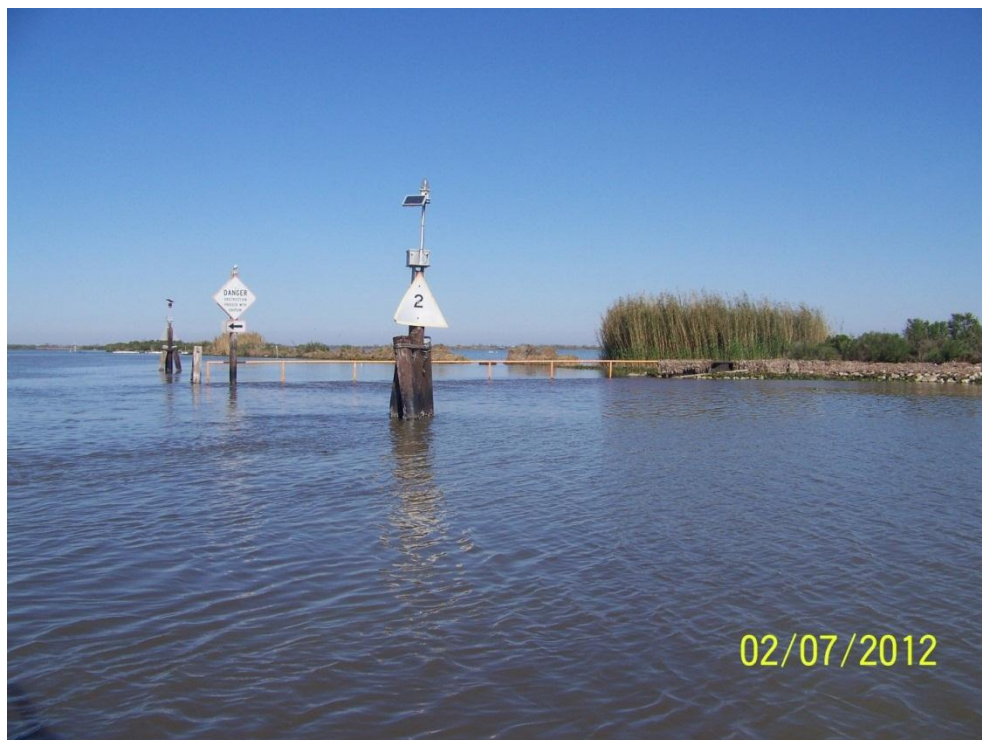
Photo #36: View of the eastern embankment tie-in of Structure 6, looking north from Bayou Decade. The timber dolphin is damaged and its repair is included in the 2012 maintenance event.

The timber cluster pile replacement shall include removal of two (2) existing timber pile structures on the south side of Structure 6 and replacing them with new treated timber piles, supports, cables and hardware. It is also recommended that the new structure be more rigid with additional lateral support. This could be accomplished by adding another batter pile to the timber pile cluster.

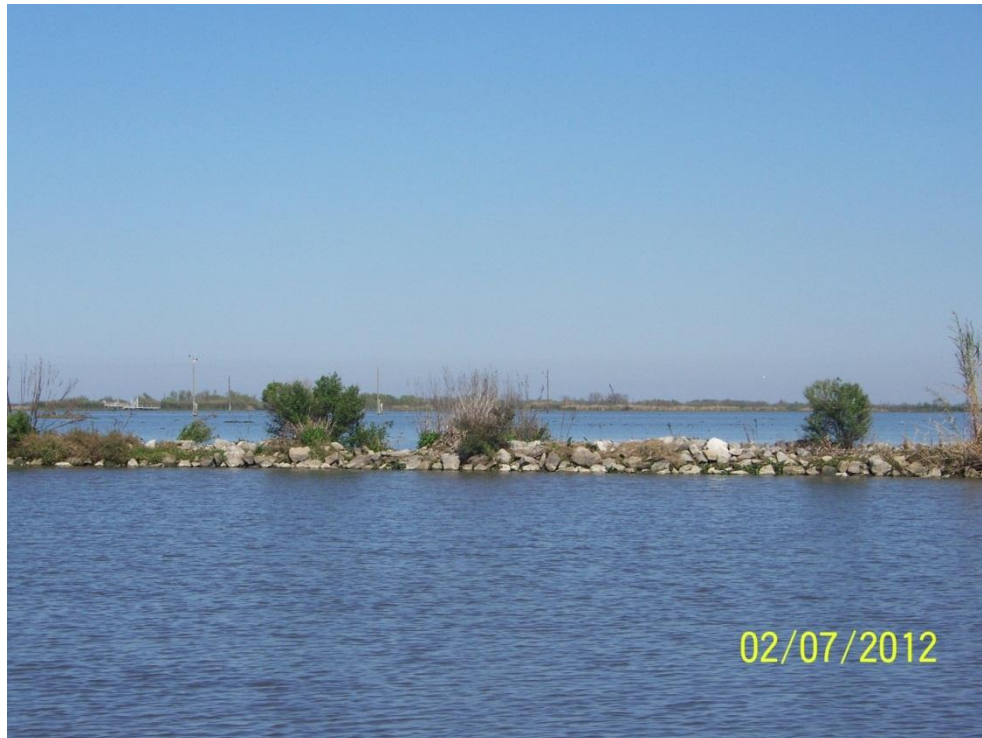
Photo #39: View of rock dike along Bayou Decade just west of Structure 6, looking north from Bayou Decade.

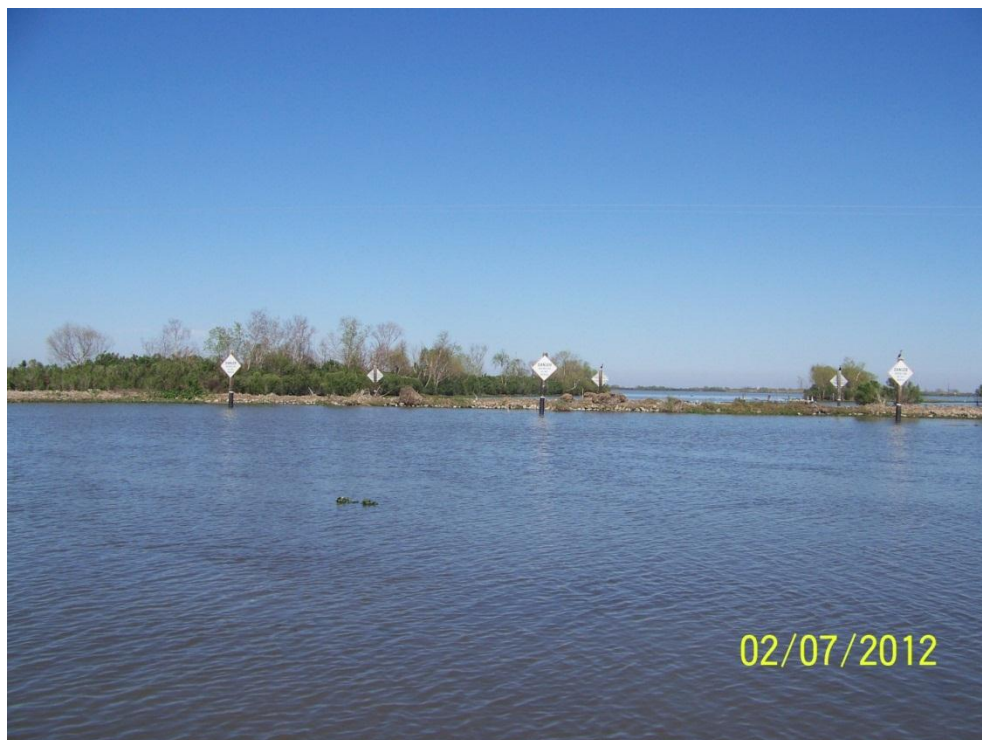
Structure 7 appears to be in good overall condition. There is no observed settlement of the rock plug or signs of erosion around the earthen embankment tie-ins. The warning signs and supports for this structure also appear to be in good condition. This structure does not require maintenance at this time. (See Appendix B, Photo #40)

Photo #40: View of Structure 7 Rock Plug along Bayou Decade, looking north from Bayou Decade. There is no observed settlement of the rock, and the signs and supports are in good shape.

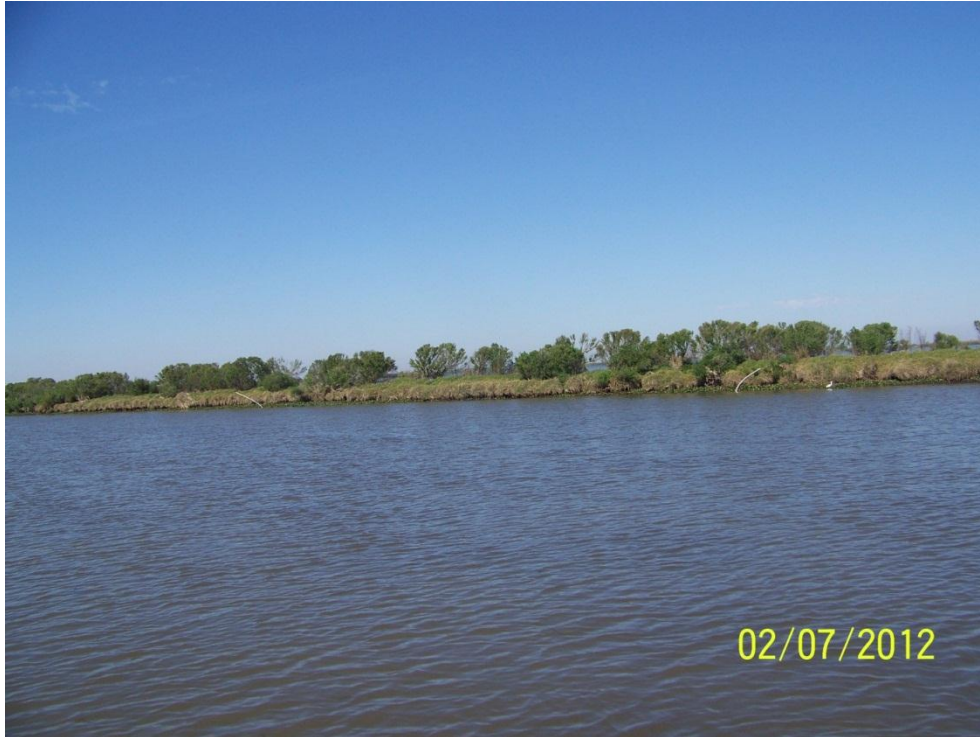
Photo #41: View of earthen embankment along Bayou Decade, located just west of Structure 7, looking north from Bayou Decade.

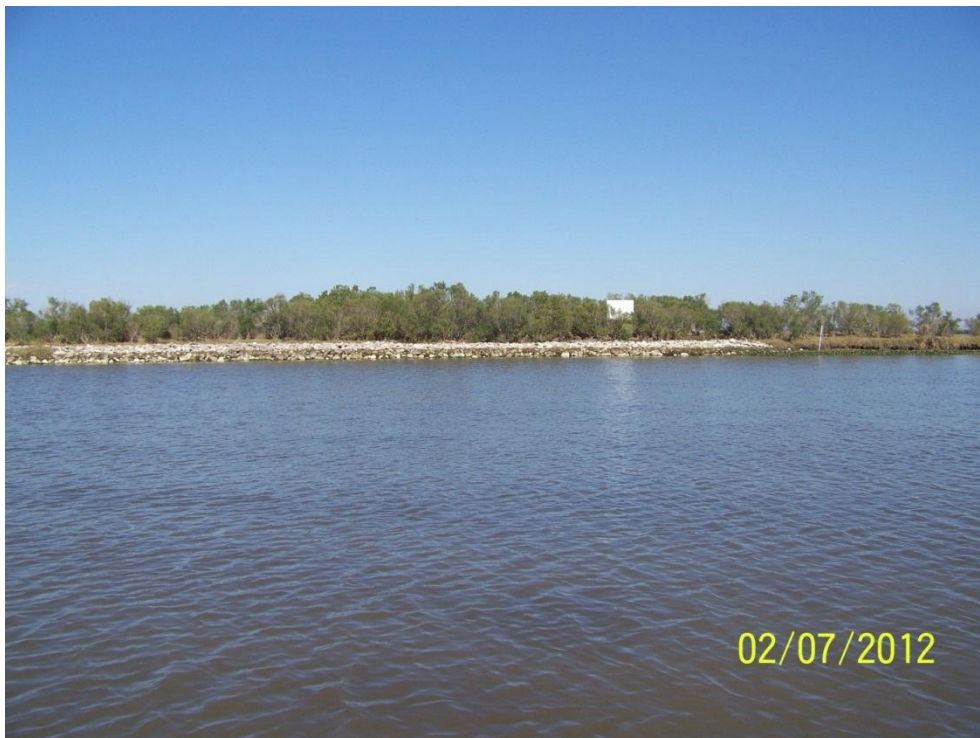
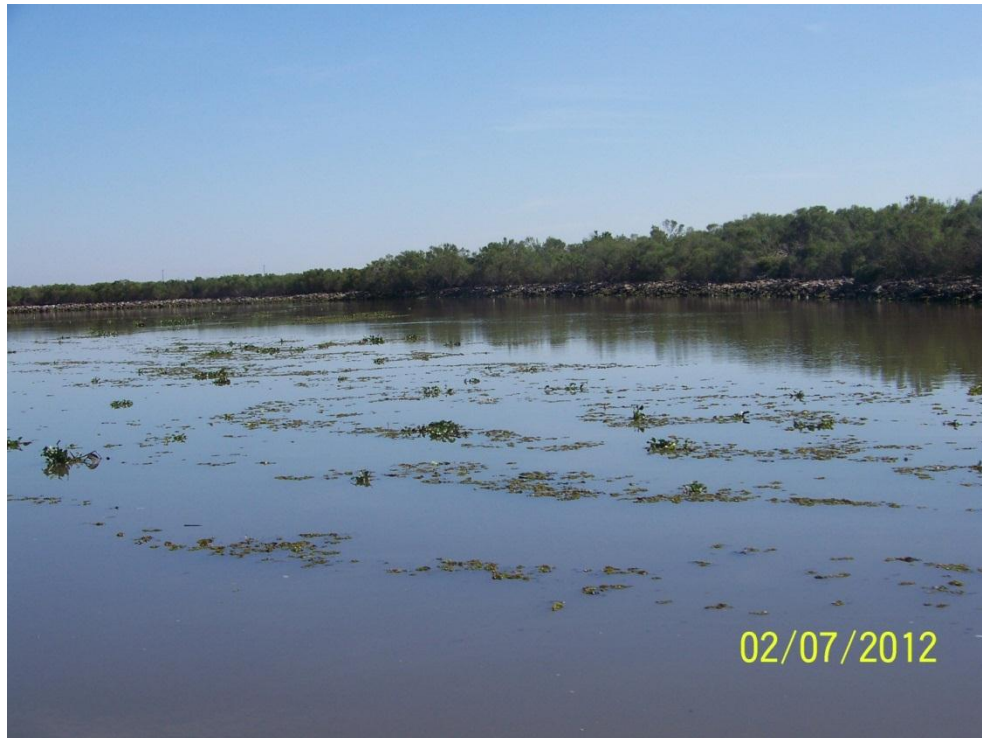
Photo #42: View of rock armored embankment located at the intersection of Bayou Decade and Voss Canal, looking northeast from Bayou Decade.

Photo #43: View of rock armored embankment along Voss Canal, looking east from Voss Canal.

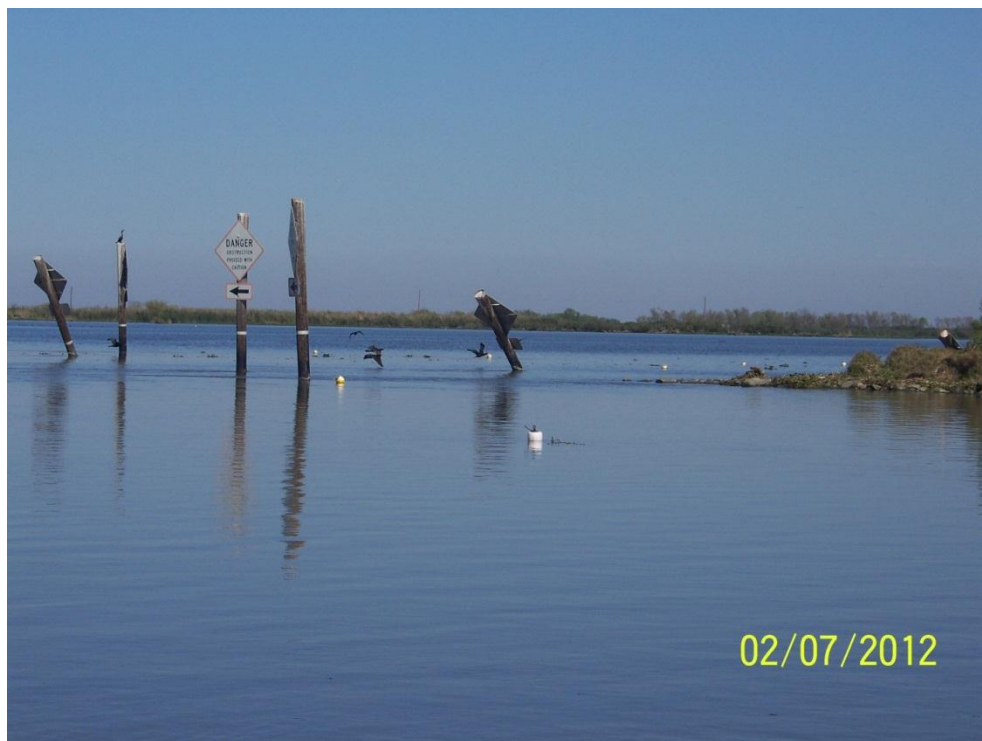
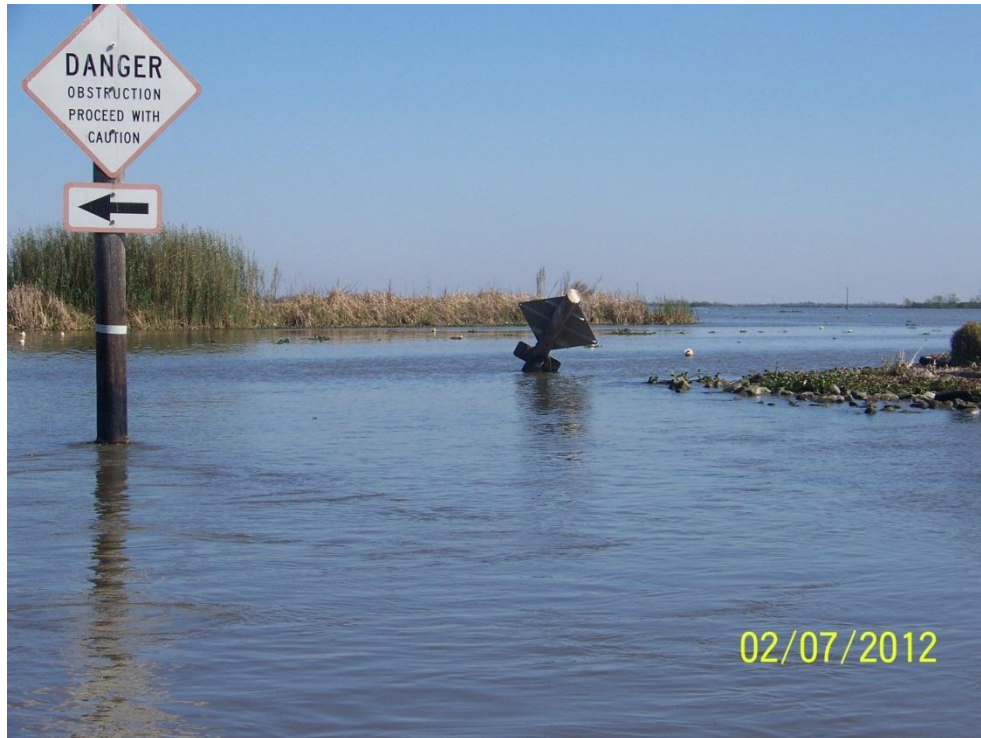
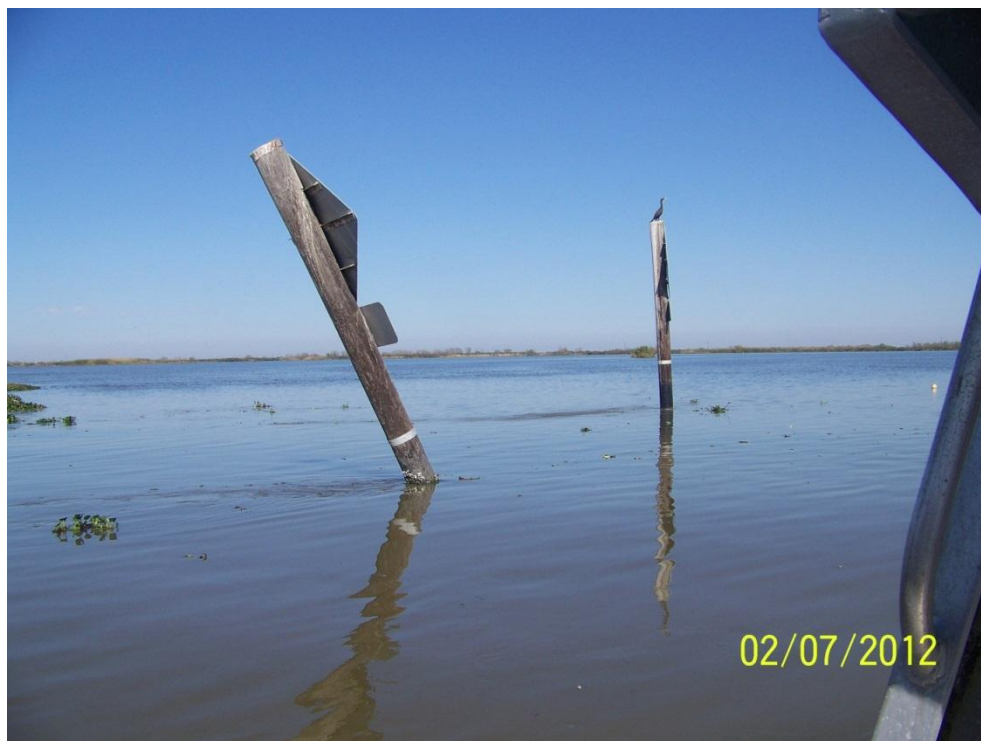
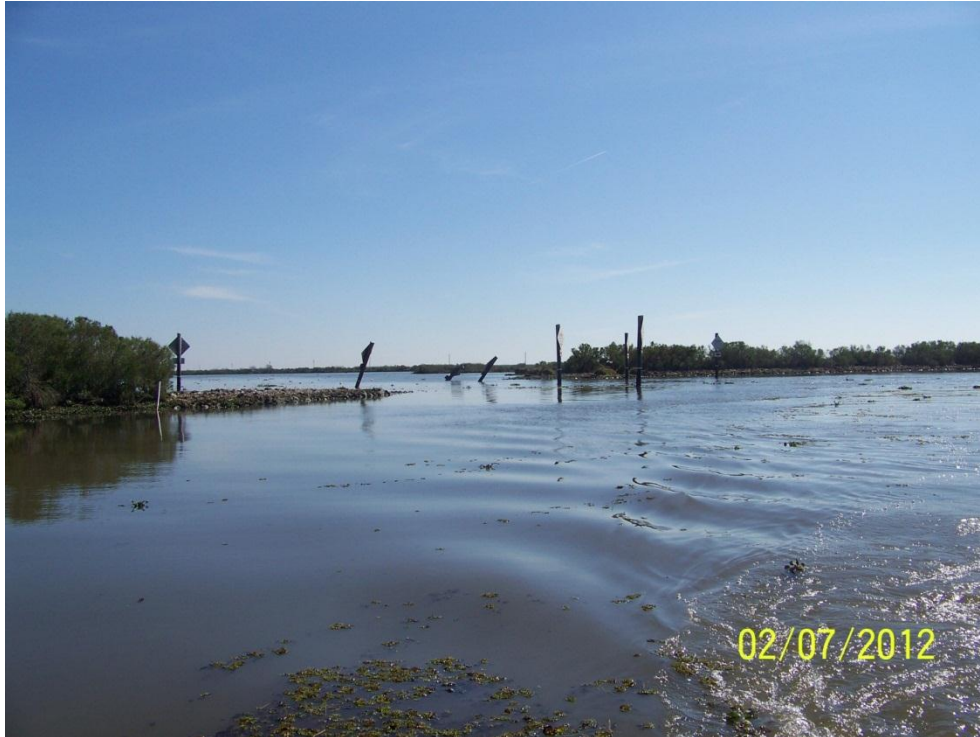
This structure along Voss Canal seems to be in good overall condition. There was no structural damage observed to the channel liner and no additional settlement of the rock from previous inspections. A handheld depth sounder was used to record the water depth in the boat bay. A reading of 5.7' of water above the rock crest combined with the earlier water level reading of +1.0' NAVD88 implies the current crest of the structure is -4.7' NAVD88. As reported in previous inspection reports, the timber supports for the warning signs on the northeast side of the structure are no longer vertical. These timbers were recommended for replacement and are included in the 2012 Maintenance Project. (See Appendix B, Photos 44 through 47)

Photo #44: View of Structure 10 from Voss Canal looking east. There are several down warning signs for Structure 10 to be replaced in the 2012 maintenance event.

Photo #45: View of a fallen sign on the southern end of Structure 10, looking northeast from Voss Canal.

Photo #46: View of a fallen sign on the northern end of Structure 10, looking north from inside the rock weir.

Photo #47: Overall view of Structure 10 looking southeast from Voss Canal.

Warning sign replacement shall include the removal of three (3) existing timber piles and signage and replacement with new material including timber piles, hardware and warning signs.

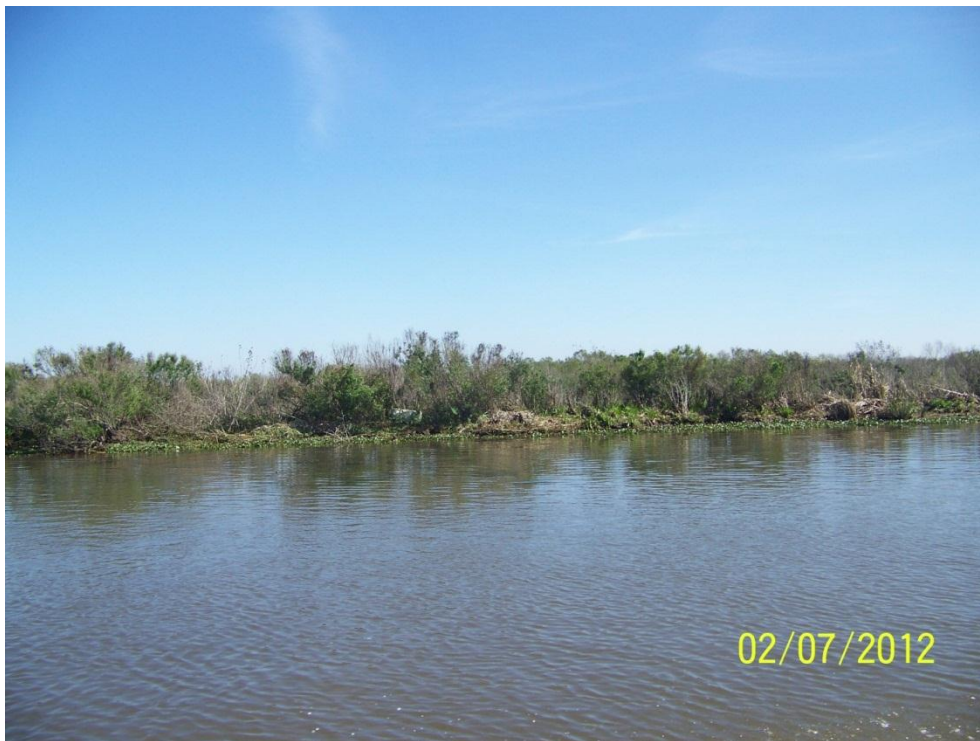
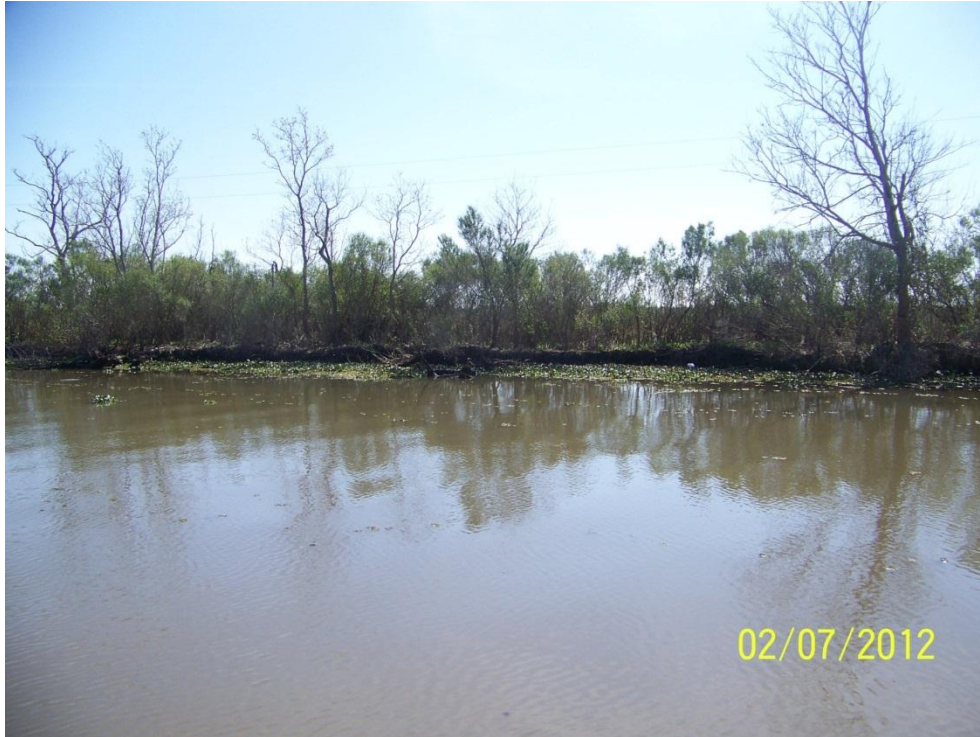
Photo #48: View of earthen embankment along Voss Canal, looking northeast from Voss Canal. No additional breaches were found between Structures 10 and 14.

Photo #49: View of earthen embankment along Voss Canal, looking northeast from Voss Canal. No additional breaches were found between Structures 10 and 14.

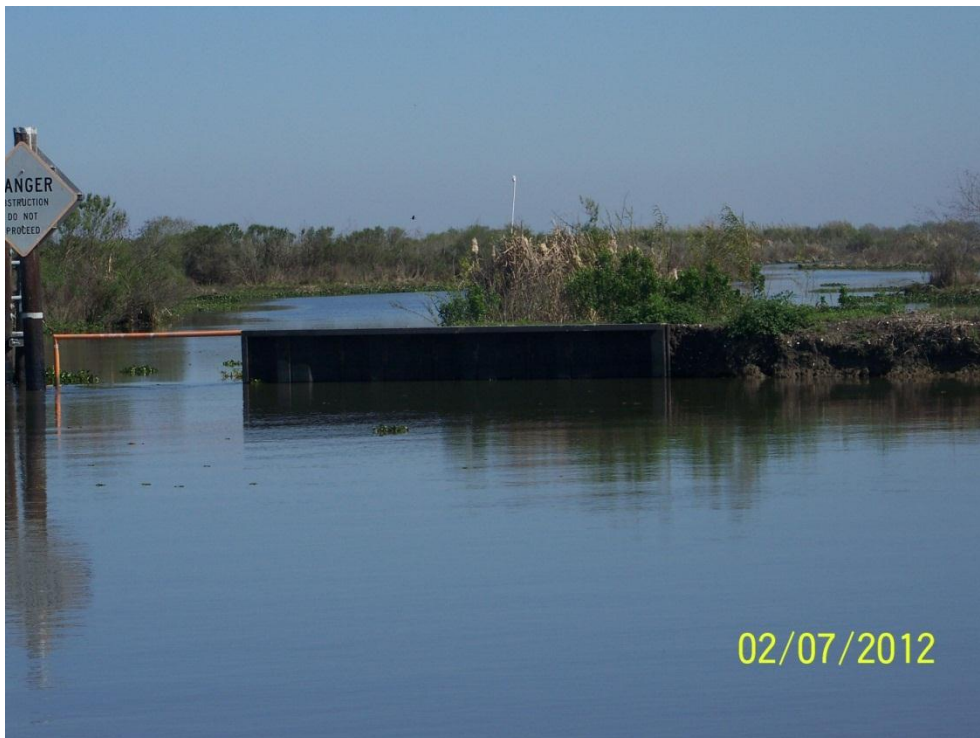
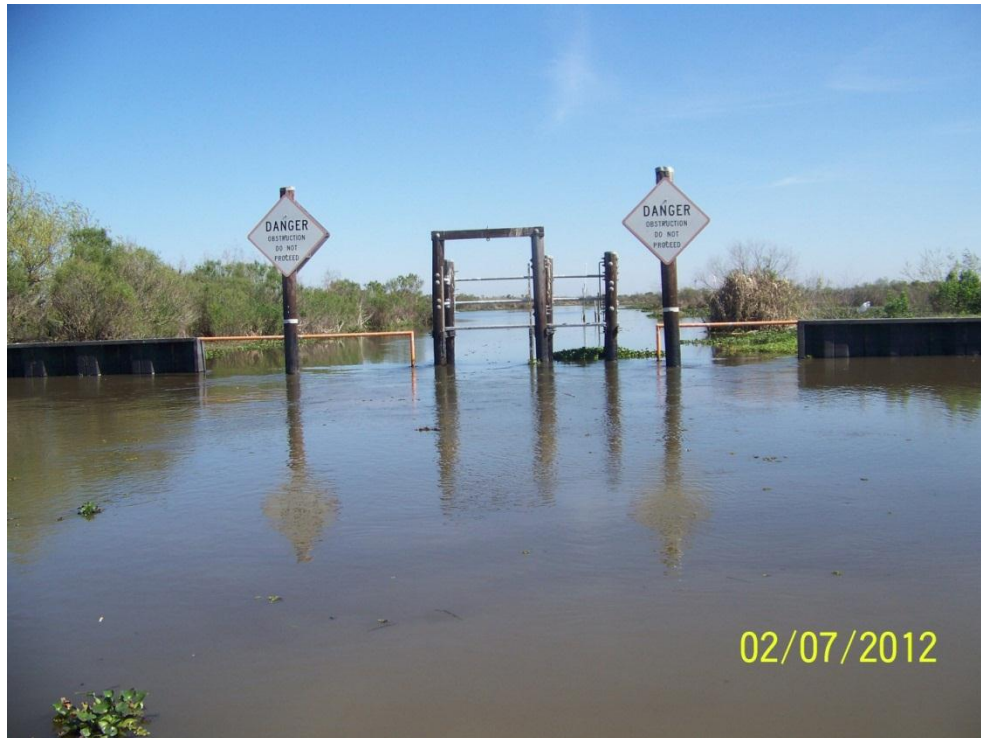
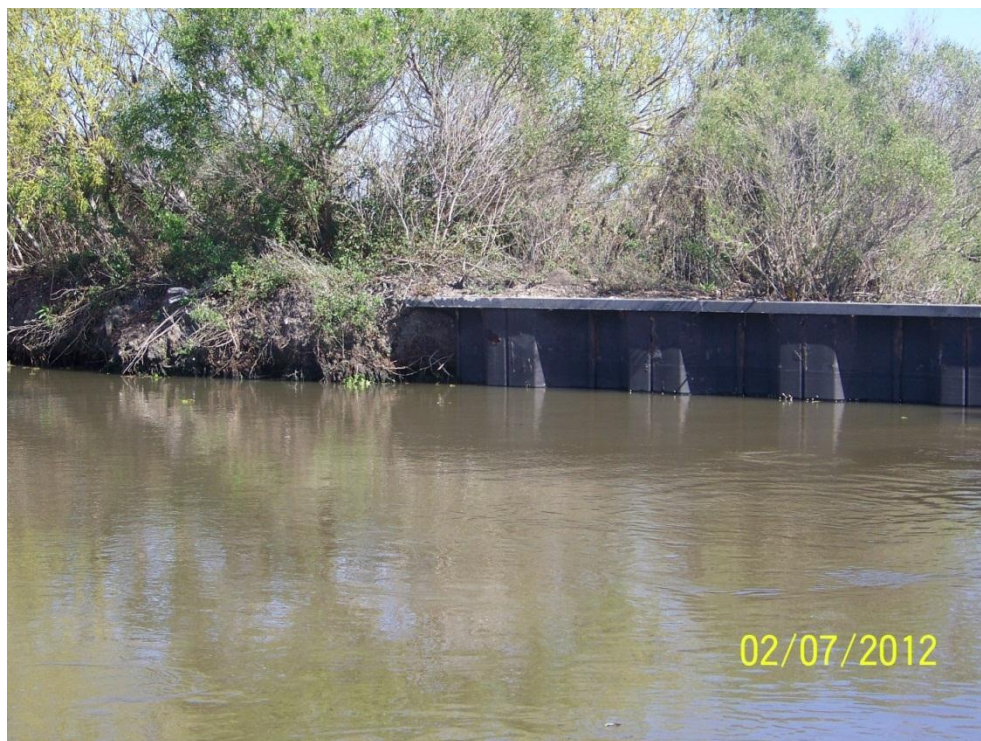
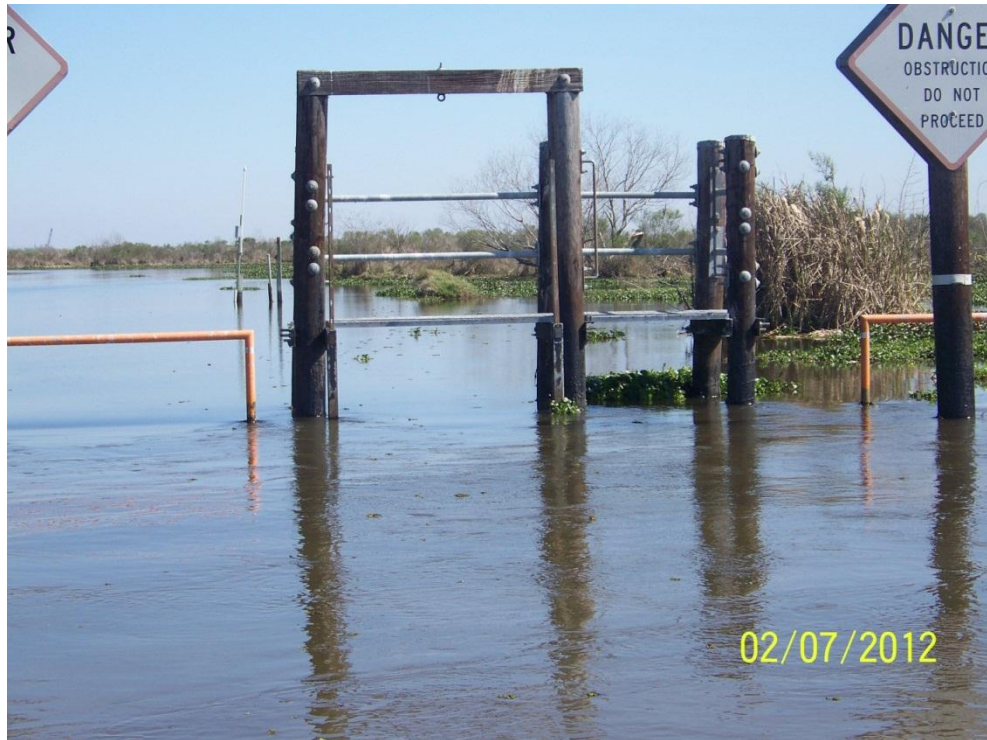
Structure 14 appears to be in good overall condition. There is no visible damage to the railings, platform, steel bulkhead, or warning signs and their timbers. As reported in previous inspection reports, there is some noticeable erosion near the embankment tie-ins. It appears to be caused by boat traffic, as the erosion can only be seen on the Bayou Carencro side of the structure. When compared to images from the 2011 annual inspection there are no indicators that the loss is progressing, and with no significant change there is no need to restore the tie-ins at this time. (See Appendix B, Photos 50 through 53)

Photo #50: View of southern embankment tie-in of Structure 14, looking east from Bayou Carencro. Both tie-ins show signs of erosion on the canal side but have not been breached.

Photo #51: Overall view of Structure 14 looking east from Bayou Carencro.

Photo #52: View of northern embankment tie-in of Structure 14, looking east from Bayou Carencro.  
Both tie-ins show signs of erosion on the canal side but have not been breached.

Photo #53: Close-up view of Structure 14 looking east from Bayou Carencro.

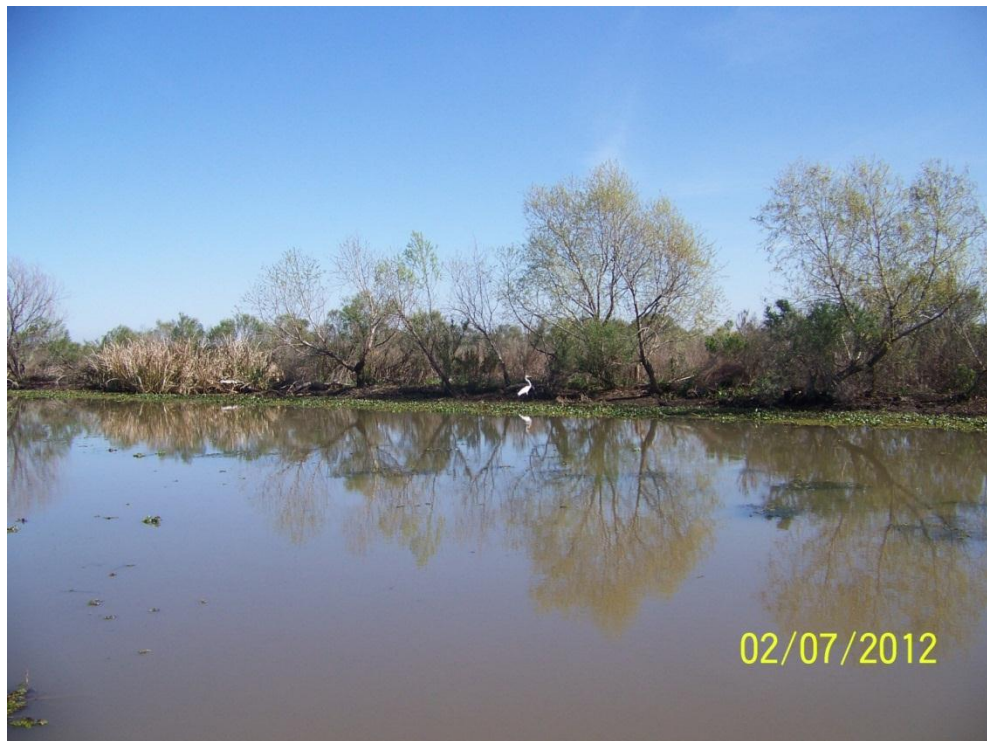
Photo #54: View of earthen embankment along Bayou Carencro, looking southeast from Bayou Carencro.

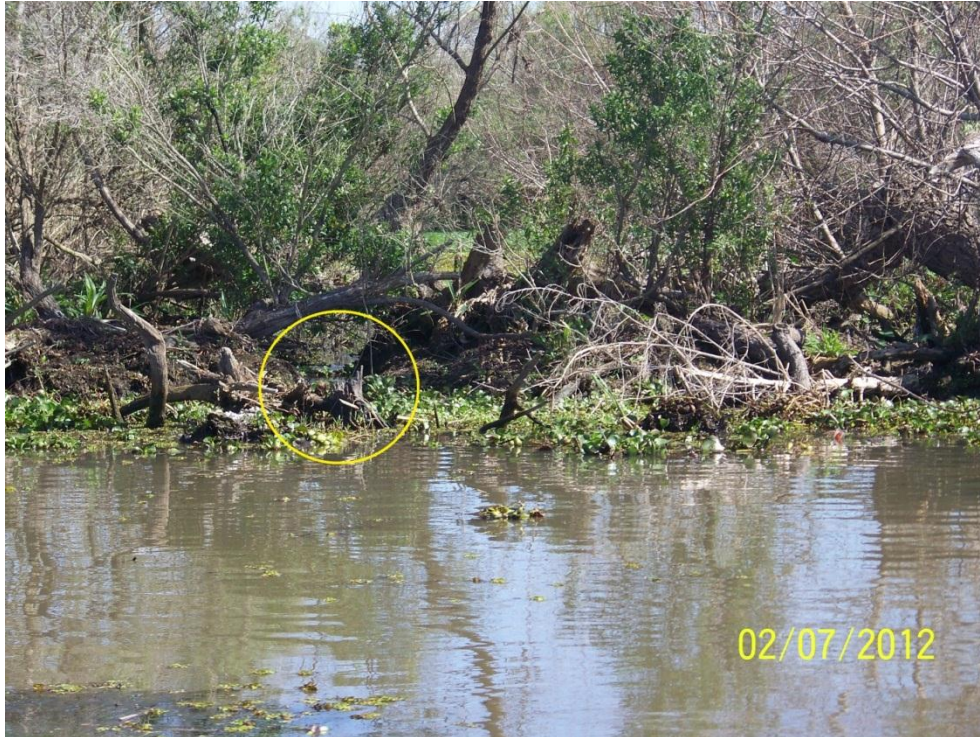
Photo #55: View of a breach identified during the 2012 annual inspection. Location in Bayou Carencro close proximity to point N29 24m 16.5s, W90 59m 52.5s
